Continuous and Jointless Transformation of Simply Supported Hollow Slab in Zhangzhou Shili Bridge

Taking a multi-span simply supported hollow slab bridge with continuous slab-deck as an example, this paper introduces the background of Zhangzhou Shili Bridge, disease and security of the bridge are investigated and analyzed. Then the possibility and design method of the continuous and jointless transformation is put forward. Finally, the paper introduces the difficult problems on the research of the transformation.

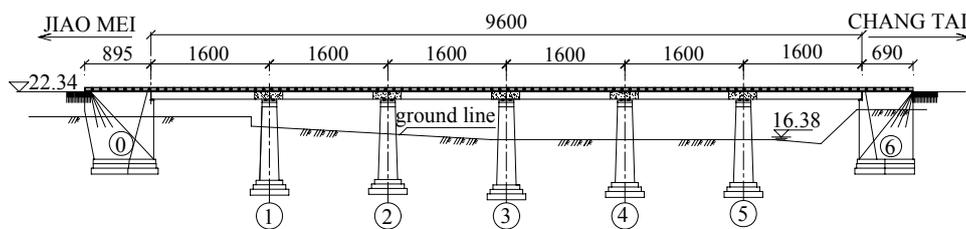
Fig.1 Elevation plans of Shili Bridge in Zhangzhou (unit:cm)

Shili Bridge is located in 503 County Road, Shili Village, Changtai County, Zhangzhou City. The bridge, with a length of 111.85 m and 6×16 m span arrangement, was built in 1995. It is designed as a simply supported hollow slab bridge with continuous RC deck, as shown in Fig.1. Shili Bridge, which is composed of old and new bridges, is a double deck bridge with center strip. The deck width is 1.75 m (sidewalk) + 9.5 m (lane) + 3.35 m (center strip) + 10.5 m (lane) + 1.75 m (sidewalk) = 26.85 m, where 9.5 m lane is the left old bridge (Fig.2). Original design load level for Shili Bridge is truck-load 20, trailer-load 100. The deck pavement adopts cement concrete. The superstructure uses precast or cast-in-place hollow slab of C30 grade concrete, and the substructure uses masonry gravity pier and open-cut expansion foundation. Fig.3 shows the picture of Shili Bridge after the completion.

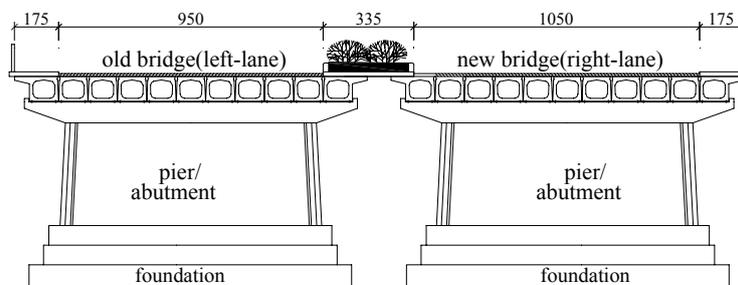
Fig.2 The standard cross-section of Shili Bridge

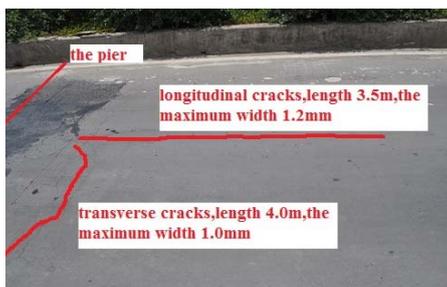
a) Multiple longitudinal cracks appeared on the bridge deck system and hollow slab beam, most were located near the hinge joints, and the maximum crack width was 1.2 mm (Fig.4 and Fig.5); there were also multiple transverse cracks appeared on the deck above the pier, the maximum crack width was up to 1mm (Fig.4); hinge joints also appeared many concrete scaling, steel bar cropped out, and waney situations (Fig.6).

Fig.4. Cracks on the bridge deck

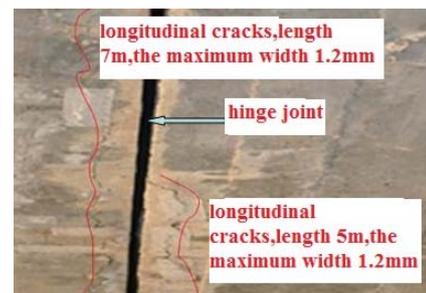
Fig.5. Cracks on the hollow slab beam

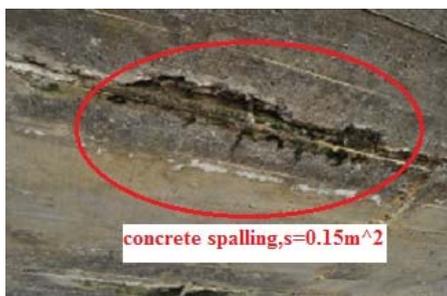
Fig.6. Concrete scaling at hinged joints

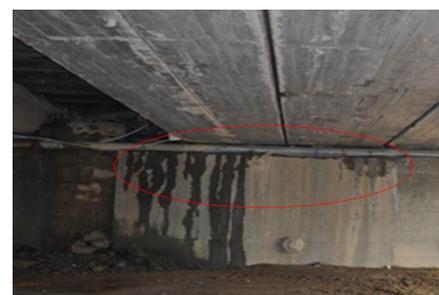
Fig.7. Seepage in pier and abutment

b) Abutment and pier was basically intact without deformation, subsidence, and cracking. Floor cracking, sliding, and moving were not found around foundation. Main disease of pier is the serious seepage (Fig.7).

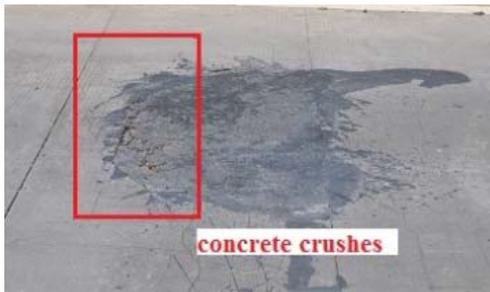
c) Pavement concrete broke seriously (Fig.8); Beam bottom closely touched the cap beam, and caused bearings damaged (Fig.9); Expansion joint device did not run through transversely in the sidewalk slab and railing, which caused blocking and deformation; Lateral slit and pavement missing appeared on some sidewalk slab; Majority of deck drains failed to function, resulting in serious surface gathered water (Fig. 10).

Fig.8. Broken concrete pavement

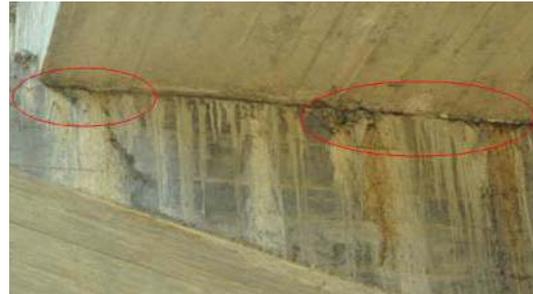
Fig.9. Attached beam bottom and cap beam

At the same time, the damaged bearings were eliminated and the new ones were reset. From theoretically analysis, single bearing and double bearing has not much difference in the influence of internal force distribution of continuous beam. Double bearing would decrease the peak of negative bending moment of continuous girder, and reduce accordingly the unloading of bending moment in the middle of the span. However, this negative impact is limited, especially for simply-supported-system to continuous-system reinforcement of commonly used 20-30 m span bridge. Therefore, from the view of the convenient construction, we adopted double bearing. All the original bearings were replaced with ordinary rubber bearings, general

laminated rubber bearing were set on the top of bridge piers, and four stainless steel PTFE laminated rubber bearings were used in the abutment to meet the deformation requirement.

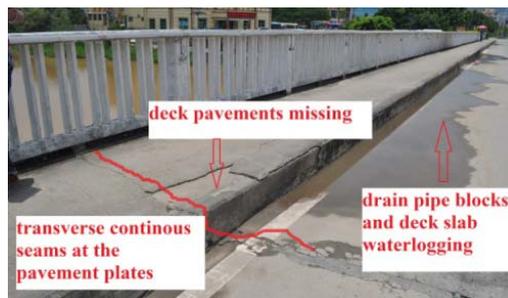
Fig.10. Deck drain malfunction

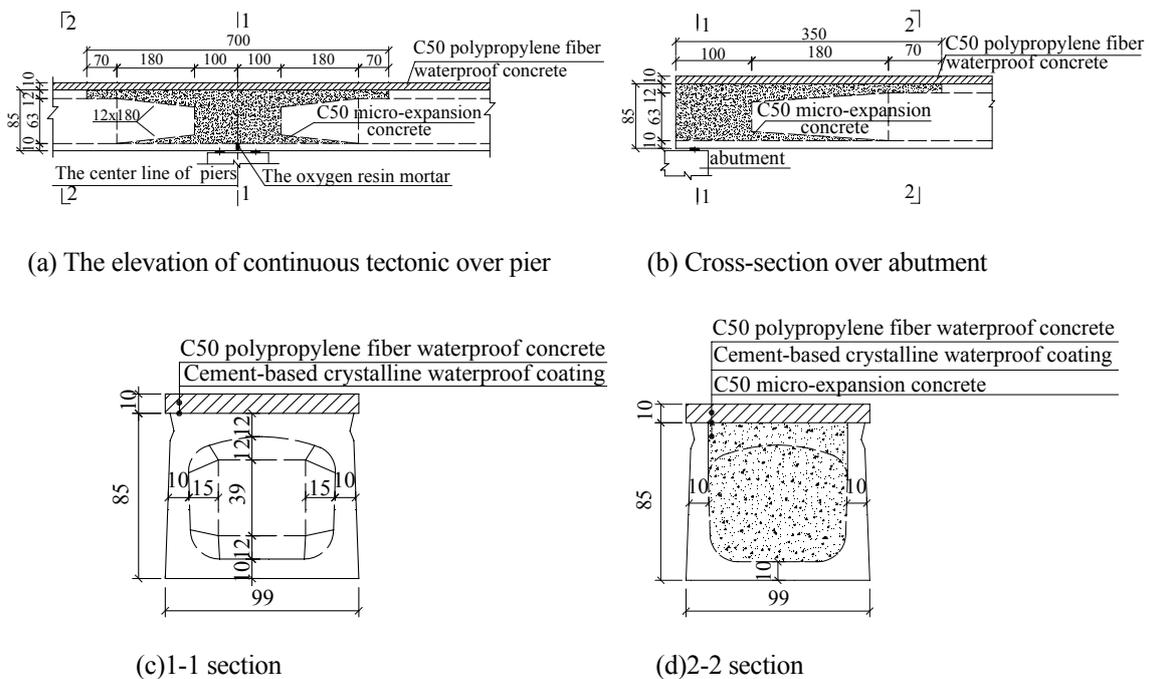
Fig. 11. Simply-supported to continuous structure system (unit: cm)

In order to form a continuous structural system, the concrete of beam end and top slab of main girder in the original bridge was chiseled at first, and the corresponding numbers of longitudinal steel bars were set up to resist negative bending moment caused by structural system transformation (shown in Fig. 11a and Fig. 11b). Then the exposed longitudinal steel bars of adjacent two beams and the negative bending moment steel bars were connected as a whole by pouring concrete. Meanwhile, the hollow portions at each end of the main girder within 1 m range were filled with micro expansive concrete of good compaction performance to ensure the integrity of pouring concrete and original main girder (Fig. 11c and Fig. 11d).

The reinforcement from simply-supported-system to continuous-system can effectively improve the flexural capacity of cross section in the midspan, but has little effect on the shear capacity of inclined section near support. Therefore, it needs to make a check of the inclined section. After check, the size of cross section near support required widening (Fig. 11c). The web plate from midspan to support was thickened by 15 cm, and 12 cm for top and bottom plates (Fig. 11d). The gradient length was 1.8 m, shown in Fig.11a and Fig.11b.

Considering the crack control of on-site concrete layer in the deck (deck above piers under negative bending moment) and waterproof problems, C50 polypropylene fiber waterproof concrete with low shrinkage and good density was used in on-site concrete layer (Fig.11c). Using fiber reinforced concrete can effectively control the concrete shrinkage crack. Meanwhile, in order to control the shrinkage crack of concrete, 10 mm diameter steel mesh was placed on the top surface of after-pouring concrete layer, ϕ 20 mm steel bars were used on the top of on-site concrete layer to resist negative bending moment at the pier top caused by structural system transformation; the negative bending moment steel bars and steel mesh were tied together in the design. A ϕ 12 mm positioning steel bar parts was also embed on the top of the slab to ensure the location of negative bending moment steel bars. Finally a layer of cement base crystalline waterproof coating was paved between on-site layer and main girder to increase the waterproofing ability of bridge deck.

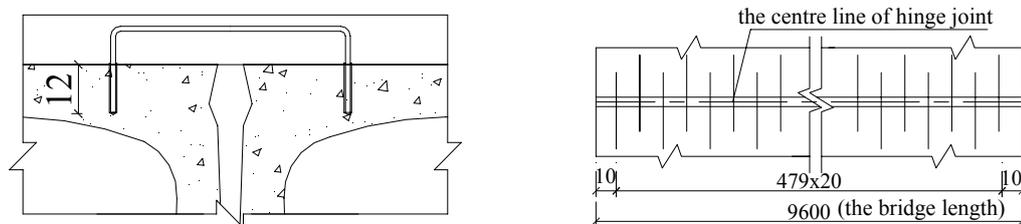
a) Details of planting steel bars

b) Arrangement plan of planting steel bar

Fig.12 Connection of on-site concrete layer and original structure (unit: cm)

In the reinforcement from simply-supported-system to continuous-system, on-site concrete layer will participate with original structure in the bridge work. Therefore, reliable connection of the on-site concrete layer and the original girder is the basis for the two parts work together. In order to strengthen their reliable connection, it is needed to do careful surface roughening on the original deck and set up the necessary shear connectors. In the Shili Bridge, the shear connectors used 20 mm diameter R235 trough reinforcements, which were arranged along hinge joints at intervals of 20 cm, as shown in Fig.12.

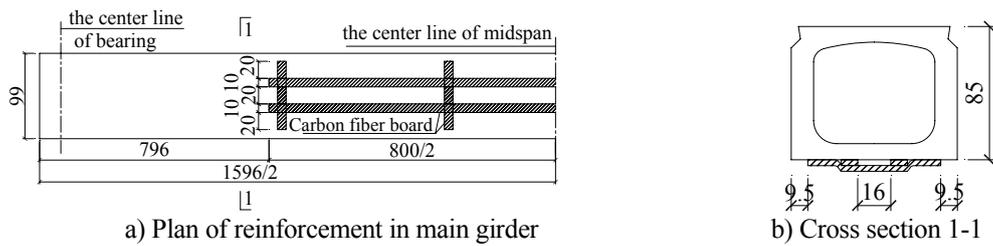
a) Plan of reinforcement in main girder
 b) Cross section 1-1
 Fig.13 Sketch of reinforcement in main girder with carbon fiber plates (unit: cm)

In order to improve the bearing capacity of the cross section of the main girder, the carbon fiber plate was adopted for its high strength, high elastic modulus, good corrosion resistance and durability, without increasing weight and volume, wide application, and convenient construction. Two 1.4 mm thick carbon fiber plates were laid at the bottom of main girders of midspan within the range of 8 m, as shown in Fig.13, to improve the ultimate bearing capacity of the main girder and safety margin of the bridge.

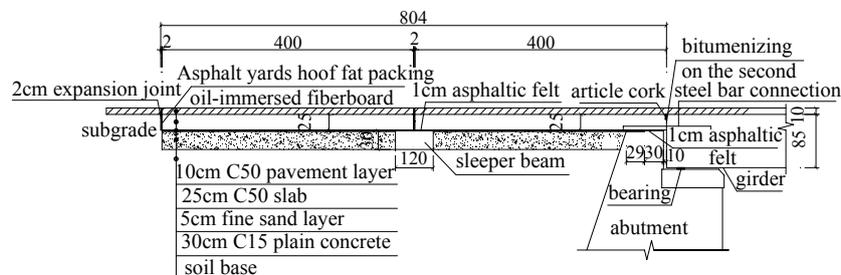
Fig.14. Elevation of jointless abutment (unit:cm)

Jointless transformation at the abutment was carried out on the basis of original design. In order to eliminate the expansion joints at both ends, the concrete within the range of 1 m in the girder at the ends of bridge was chiseled; the height of back wall of the old abutment was lowered, and re-poured concrete between the girder and slab to make slab cross the back wall and closely connect with main girder (Fig. 14).

Superstructure still retained the original abutments and bearings. A sliding surface (1 cm layer of asphaltic felt) was set on the top of back wall to make the deck system extend longitudinally under temperature deformation. The slab behind abutment should be placed on the backfill layer with smooth surface and low friction. Therefore, 5 cm thick layer of silver sand was laid under the slab to reduce the friction between slab and foundation for transmitting the stretching deformation from main girder. A construction joint (spline filled in the upper edge of joint) was set up between the beam ends and slab, aligned with the inside of the back wall, to establish a connection hinge to prevent the transmission of bending moment and control cracks. Meanwhile, the lower-part-transfixion-reinforcement connection was adopted to transmit the axial force at the joints between main girder and slab.
